From: Nicole Ward <nicole.ward@wasteconnections.com>
Sent: Wednesday, July 3, 2024 6:00 PM
To: Larry Israel; Jones, Art; Christopher Fear
Cc: Gerardo Vergara; Christina Ojeda; Amanda Sanders
Subject: RE: SITE INSPECTION OF JUNE 12TH - AREAS OF DISCOLORATION VISIBLE IN THE GEOMEMBRANE
Attachments: discoloration 1.jpg; discoloration 2.jpg; discoloration 3.jpg

Subject: SITE INSPECTION OF JUNE 12TH - AREAS OF DISCOLORATION VISIBLE IN THE GEOMEMBRANE

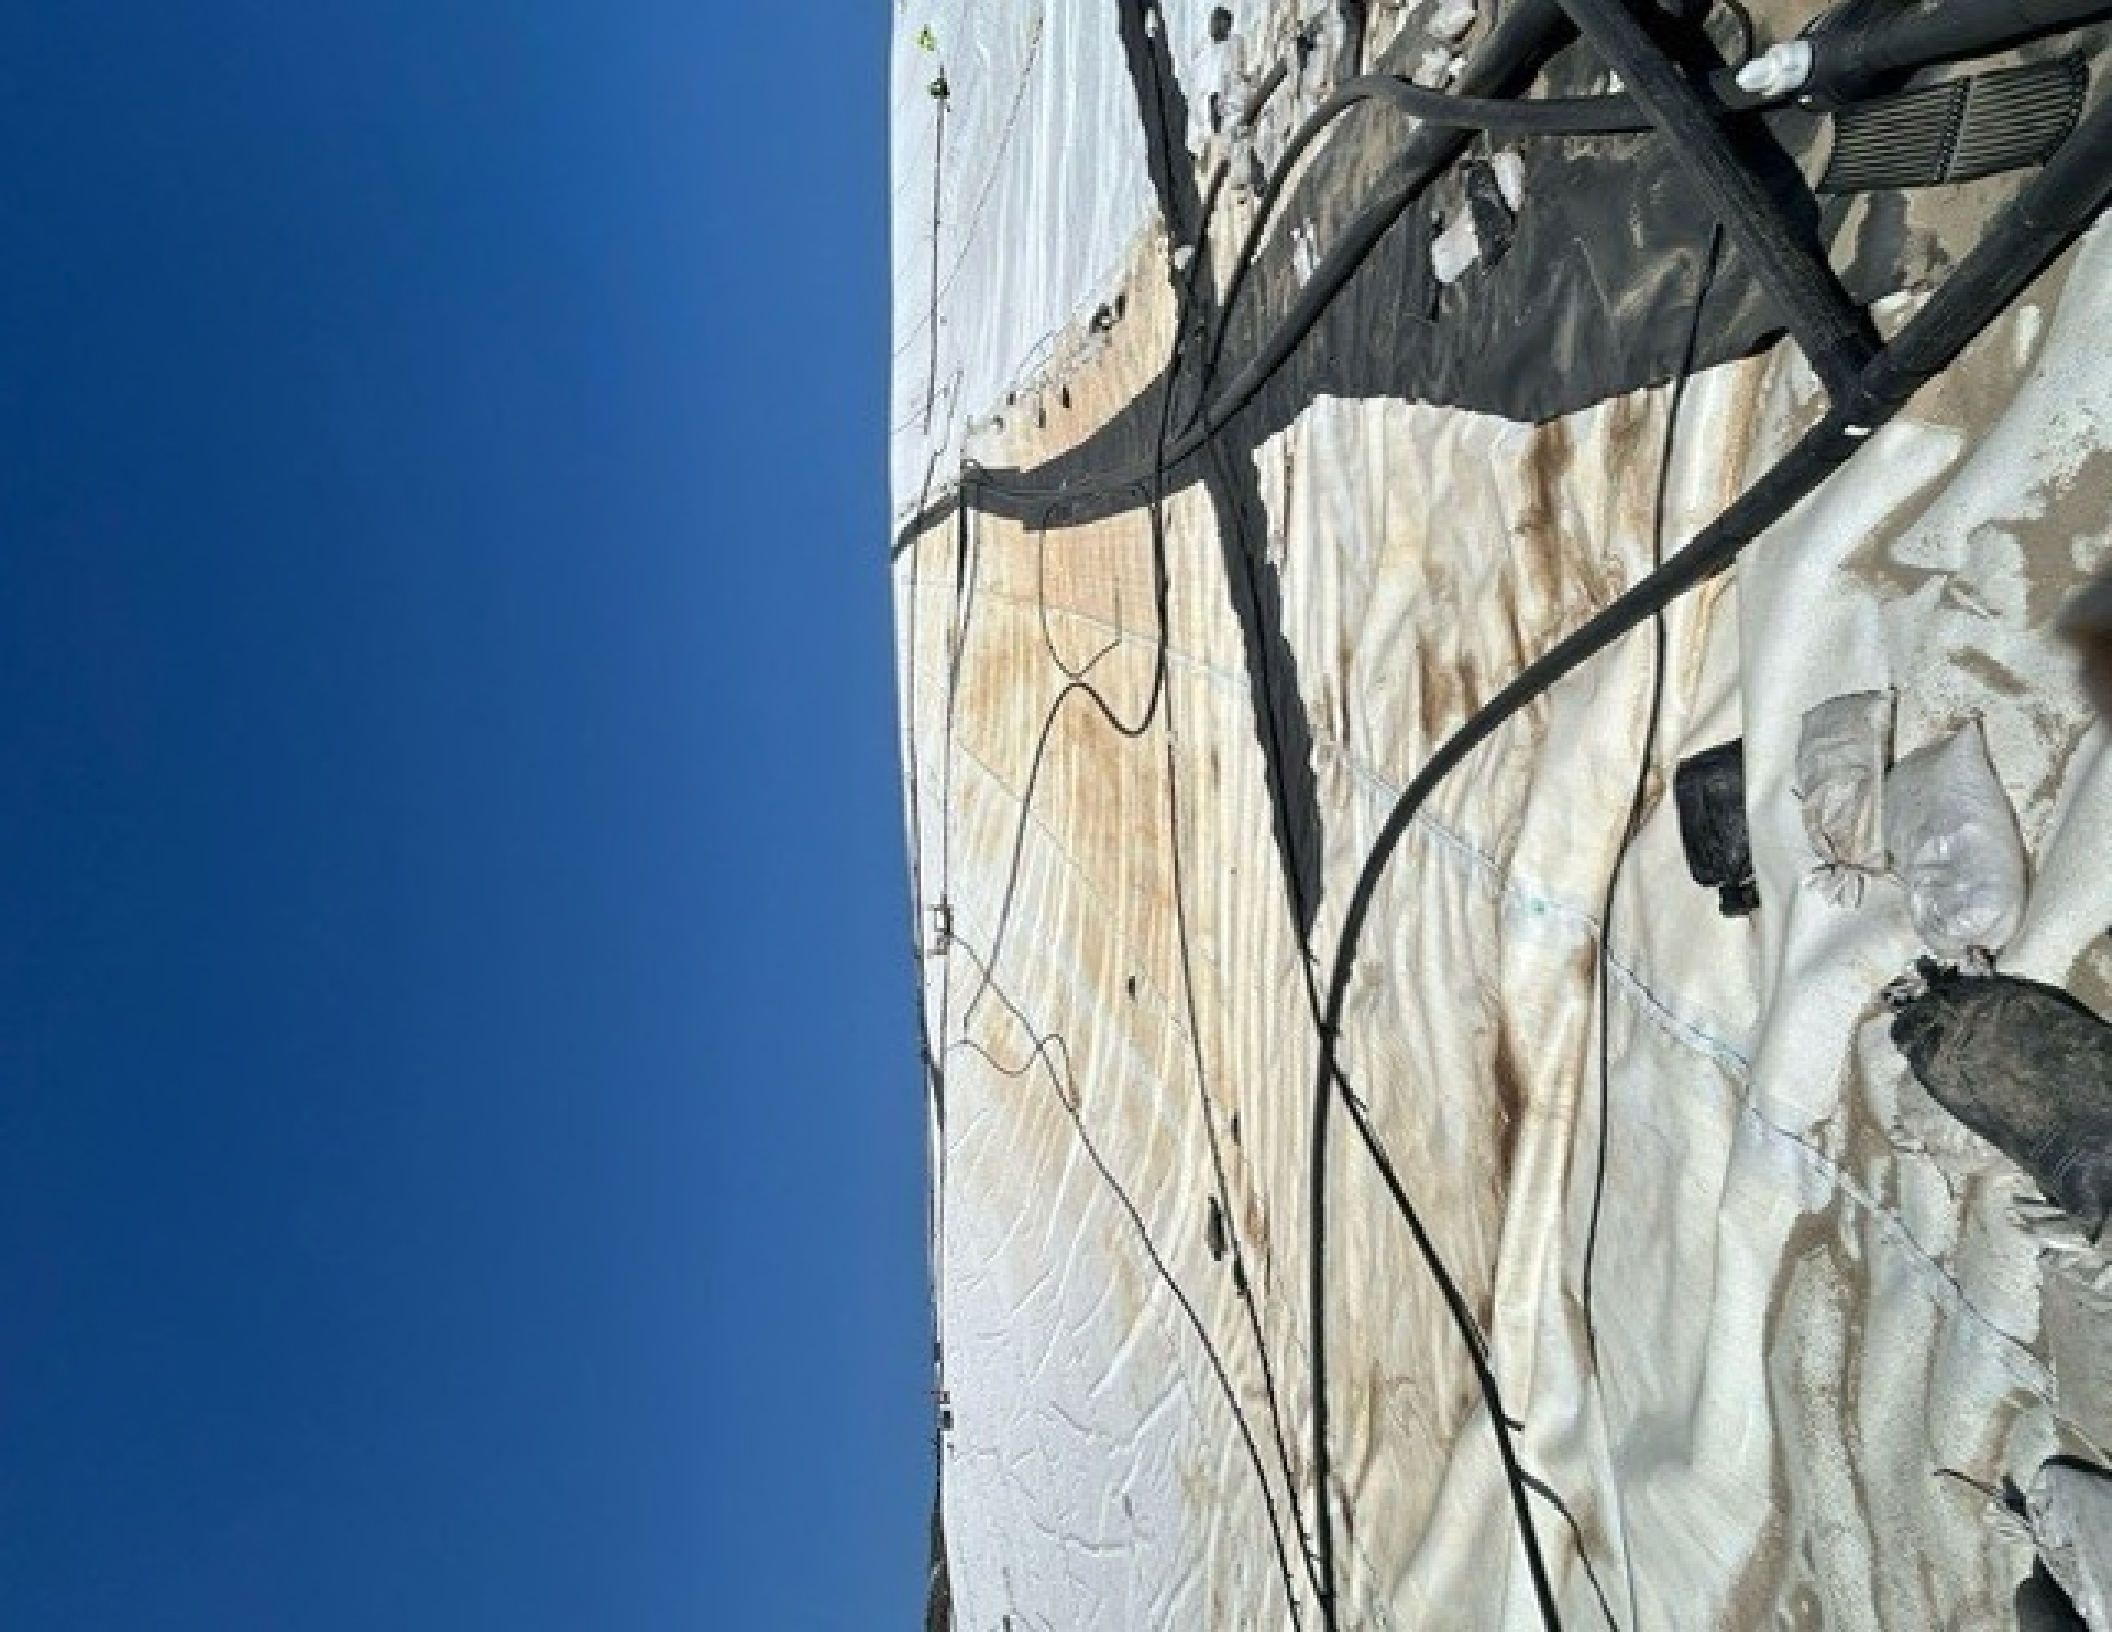
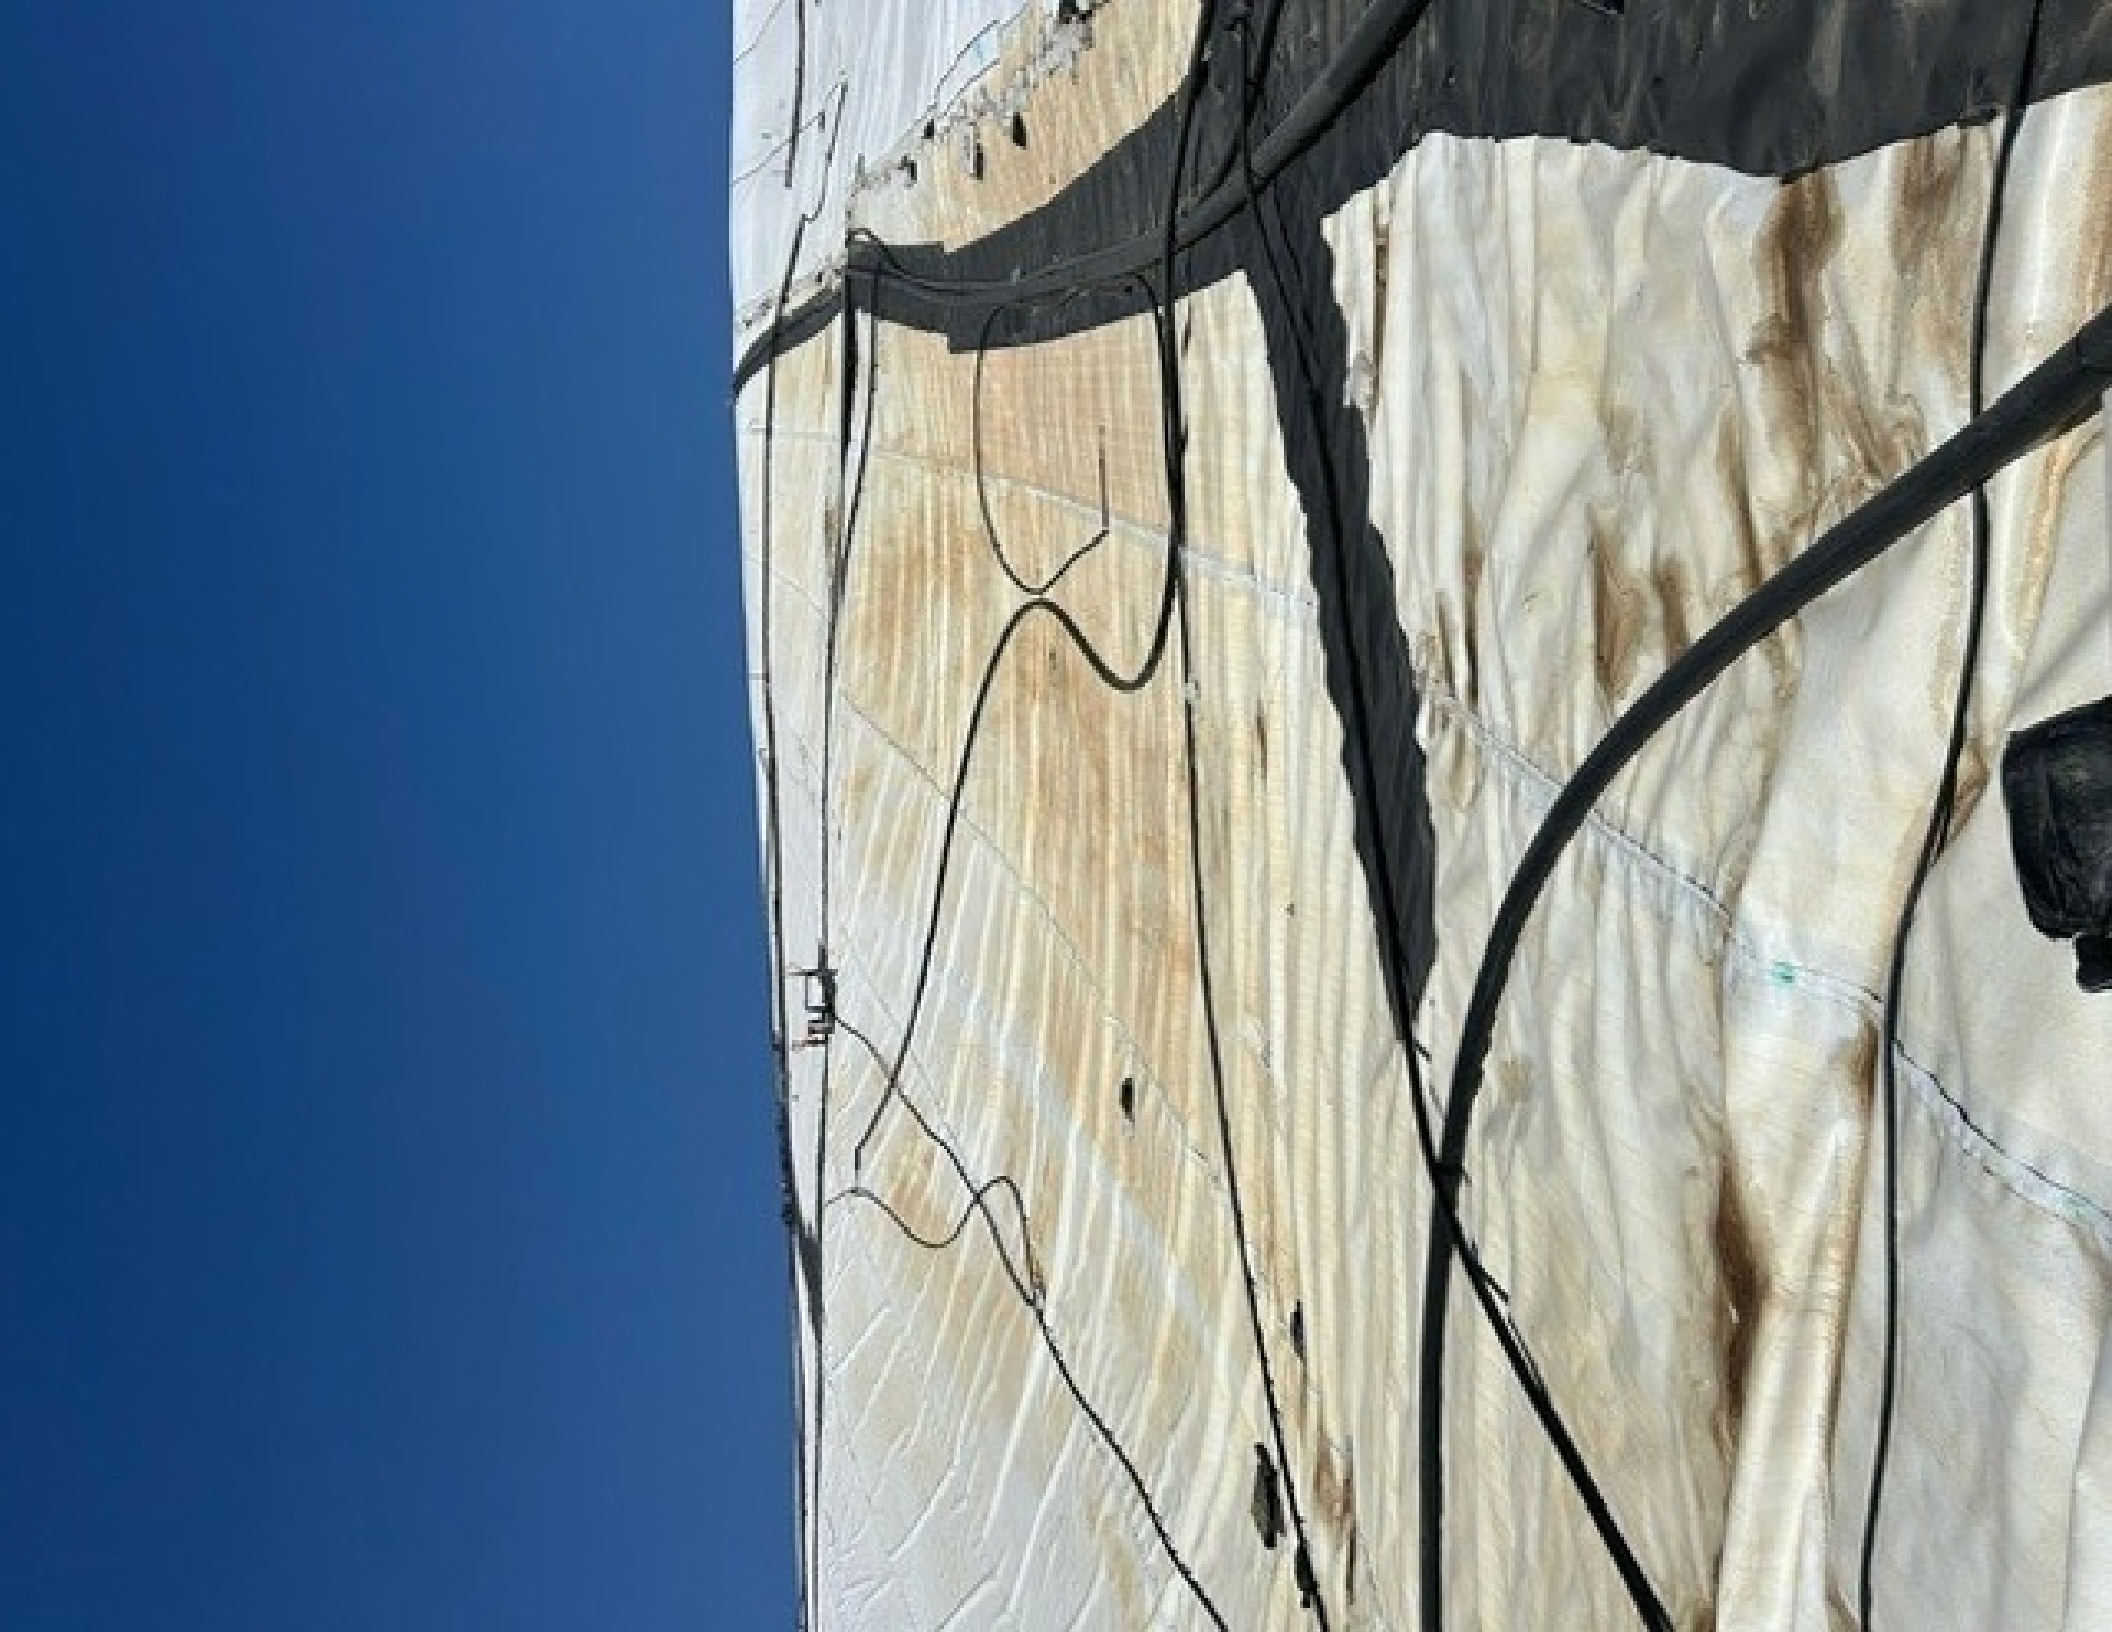
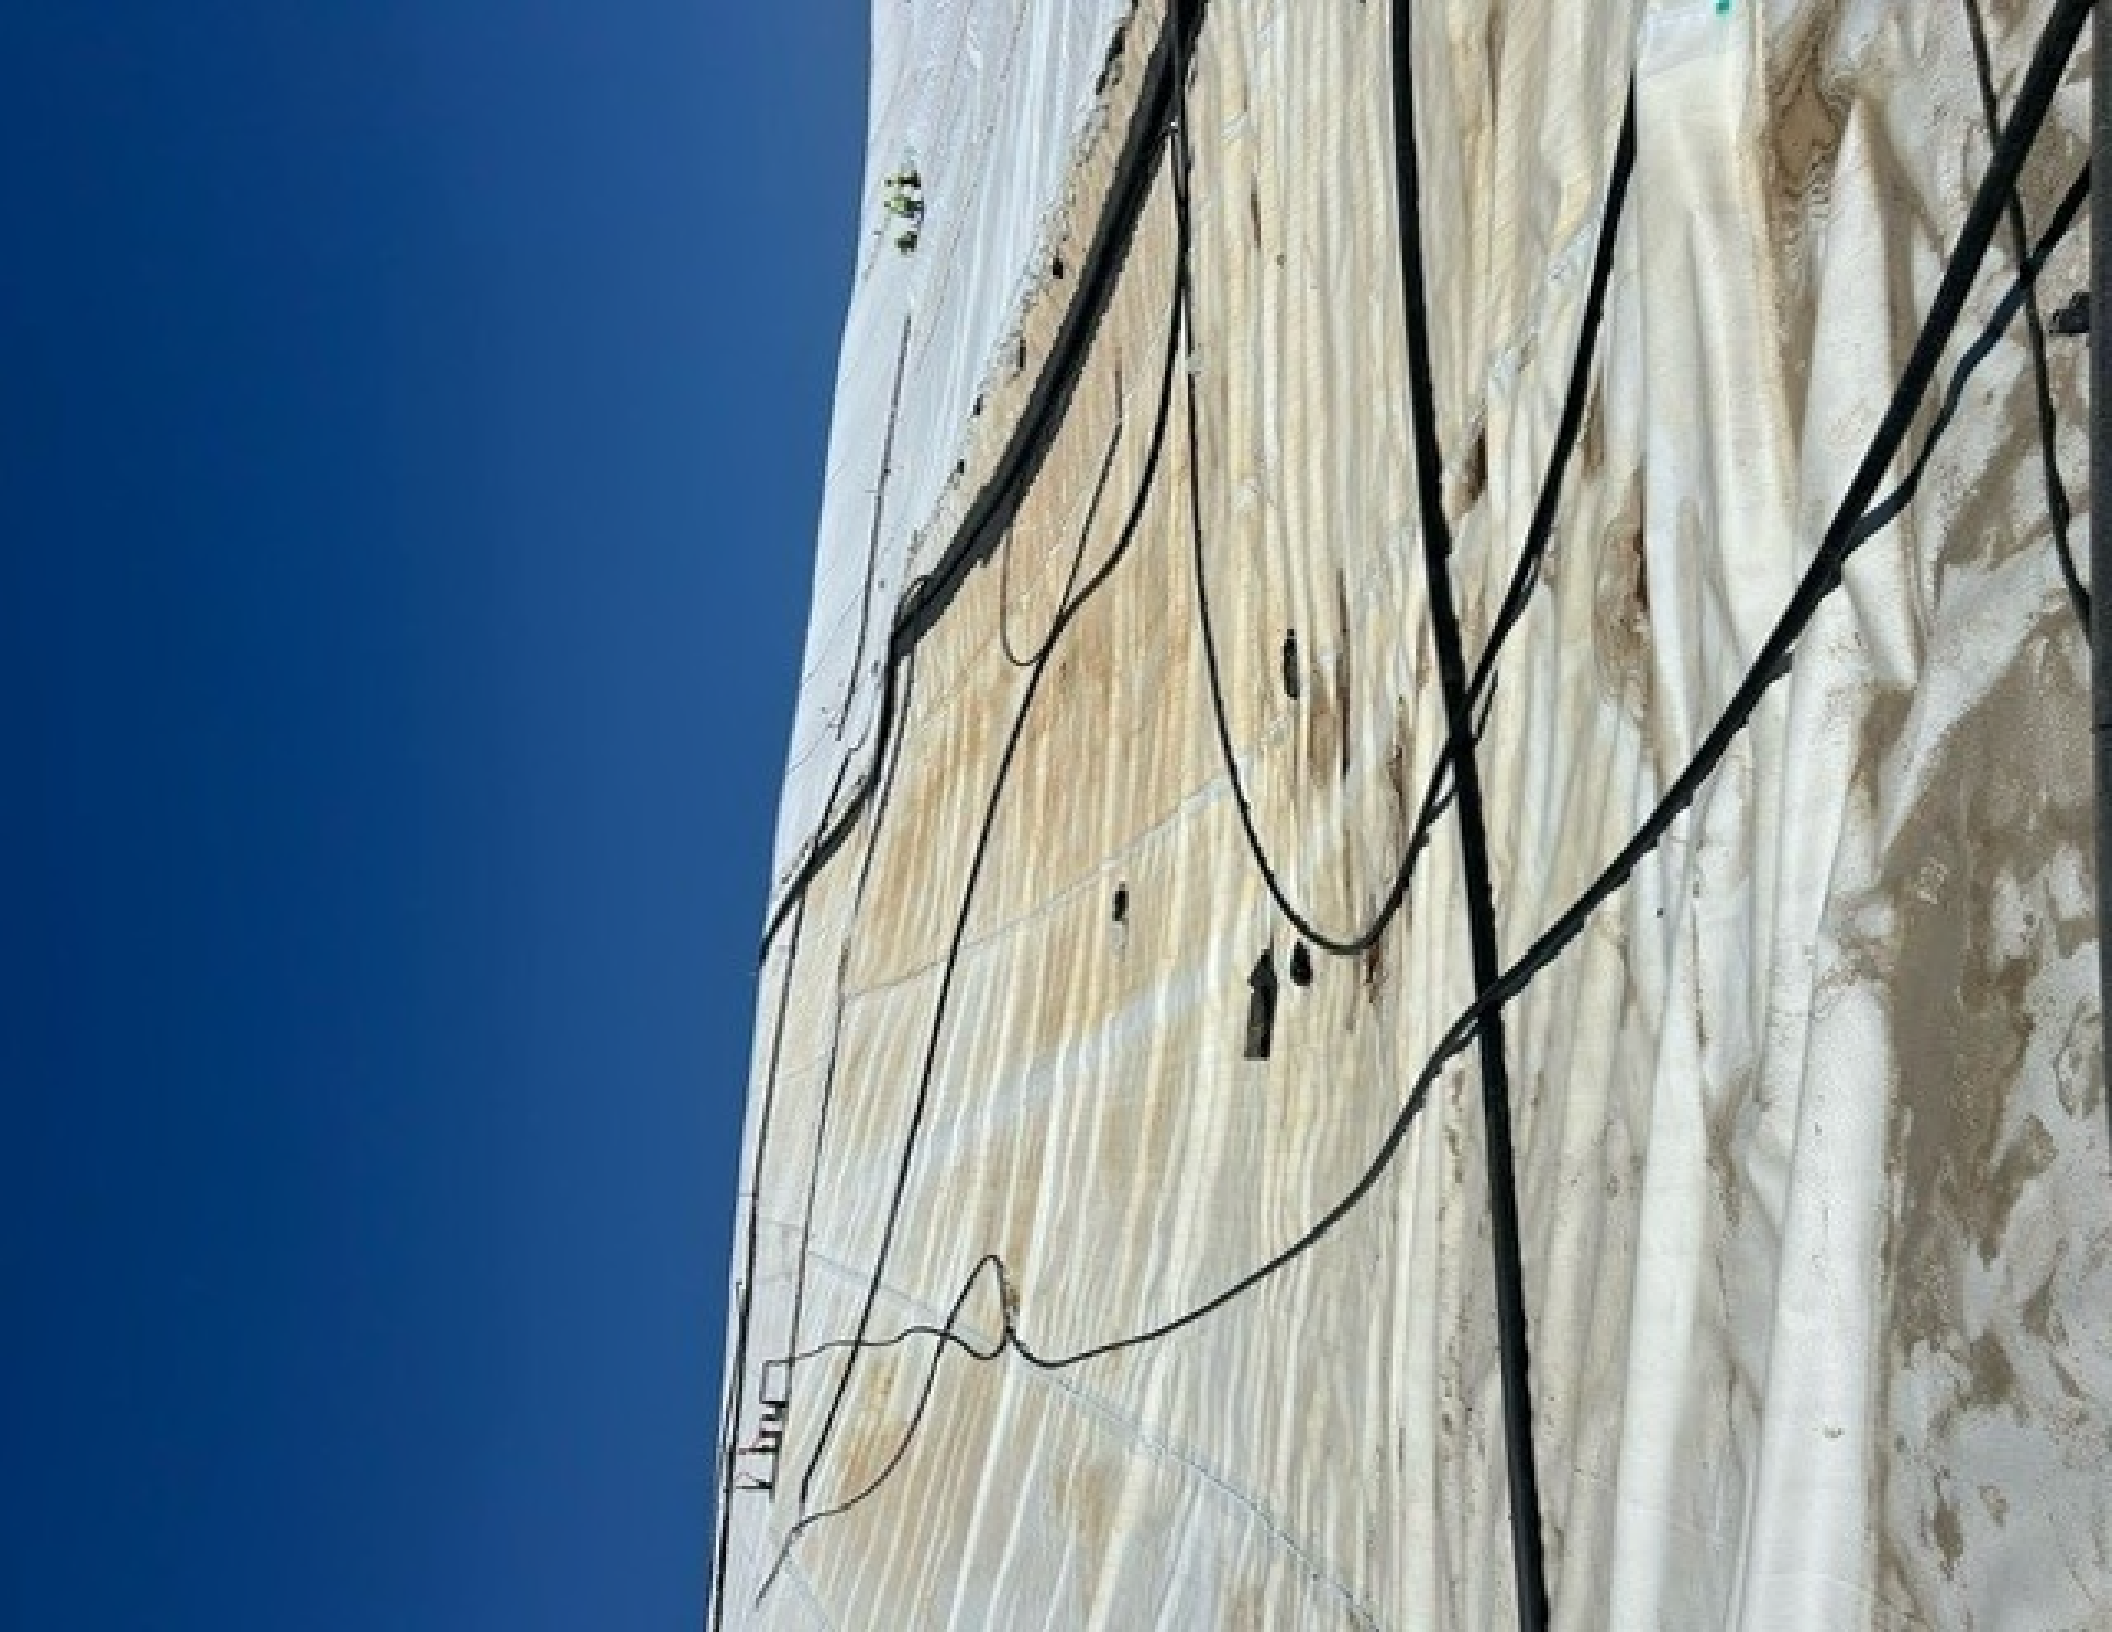
The pictures attached to this email depict areas of discoloration (staining) that is visible in the geomembrane currently placed adjacent to the scrim area in grid areas 175, 176, 180, and 181. This staining occurred under the cover when some of the force main piping and other gas and liquid infrastructure was temporarily removed from that area to install the geosynthetic cover in early May. While the system was temporarily offline to install the cover, gas and liquids moved up vertically and caused staining of the cover from underneath the cover. The cover contained the gas and liquids. In response, on May 14 and 15, Chiquita cut a portion of the geomembrane liner, installed an 8-foot stainless steel perforated horizontal pipe into the ground running parallel to the scrim, and ran approximately 120 feet of pipe with a riser to vacuum leachate from that area. Chiquita then re-installed the liner over the top of this area and pressure washed the liner. The staining remained on the washed liner. We have had the liner inspected and are confident that neither the staining nor the repair impacted the integrity of the liner. Notwithstanding, we continue to inspect this area daily. Chiquita also continues to install additional vertical landfill gas extraction wells and related gas and liquid infrastructure pursuant to the Stipulated Order to collect and convey the landfill gas to the flares and the leachate to the tanks, including installing landfill gas surface collectors underneath the geomembrane liner.
